Embankment Monitoring: Hamm Railway

CLIENT: DEUTSCHE BAHN/DB NETZAG

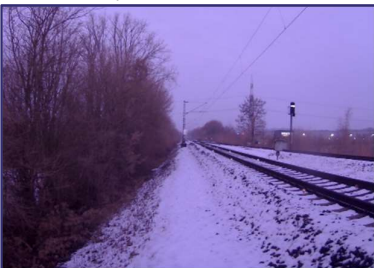
FlatMesh® Camera providing clear images 24/7

During the late winter period, up to 9mm of movement was detected by multiple sensor nodes in the at-risk area during a one-week period, before returning back to the baseline. The FlatMesh® camera images could easily be accessed remotely and clearly showed that the area experienced snow during this time, which indicates that the movement was caused by extreme variations in temperature causing the ground to contract/expand.

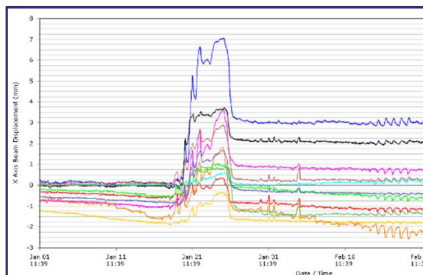
Graph showing tilt data during cold weather
